**LAKE KANAWAUKE DAM**  
ROCKLAND COUNTY, NEW YORK

NY 58  
**PHASE I INSPECTION REPORT**  
**NATIONAL DAM SAFETY PROGRAM**

Prepared by  
JOSEPH S. WARD & ASSOCIATES  
CONSULTING ENGINEERS  
91 ROSELAND AVENUE, P.O. BOX 91  
CALDWELL, NEW JERSEY 07006

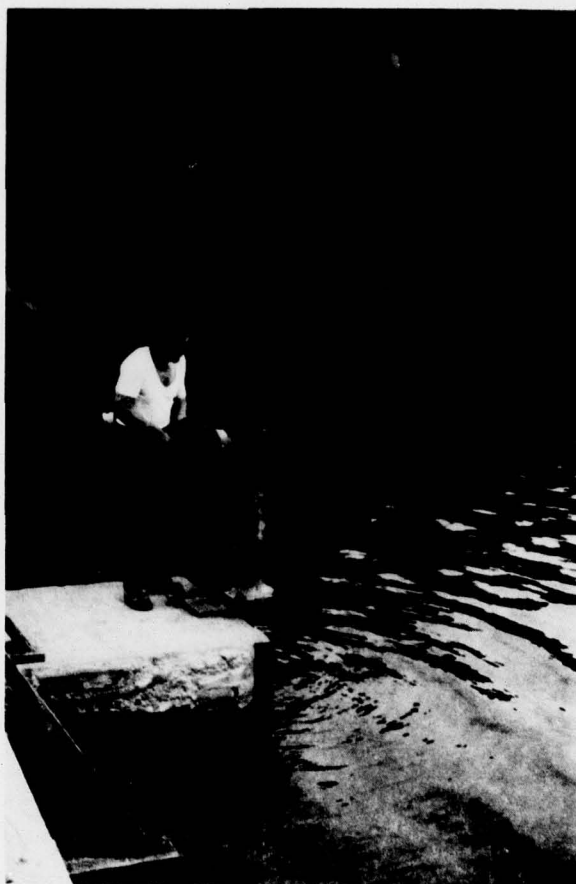
2) The sluice gate controls were operated (Fig. 1, Appendix D) and were observed to function satisfactorily. The gate itself could not be inspected since it was totally submerged. The outlet tunnel was inspected at its exit point and was found to be severely scaled and cracked (Fig. 3, Appendix D).

FIGURE 1 SLUICE GATE CONTROLS

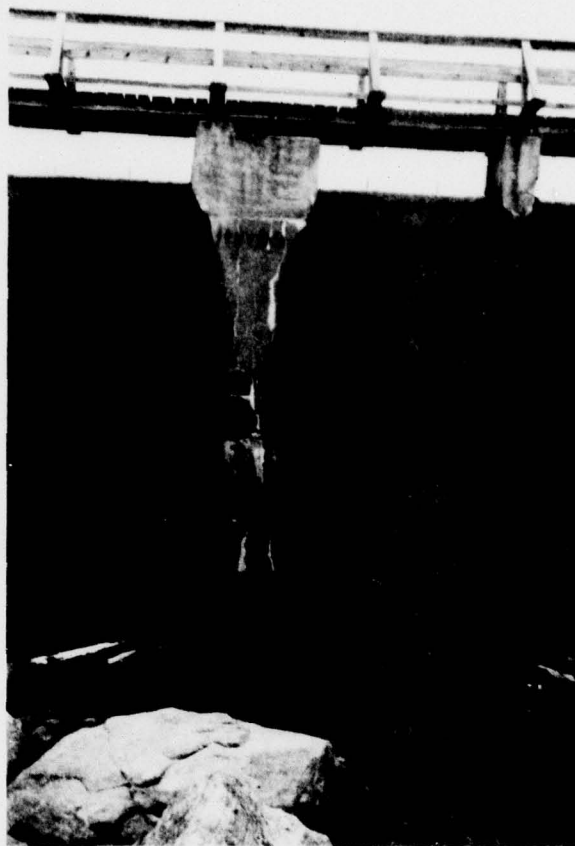
- 1) A number of spalls in the gunite cover of the downstream face (Fig. 3, Appendix D). These ranged from large to small, mostly in the center portion of the structure. The exposed wire fabric was badly rusted. In some instances the spalling had occurred at joints, and the copper baffle was clearly visible. The fact that there is evidence of patches indicates that this spalling has been a recurring problem for some time.

3) Evidence of severe to very severe scaling of the piers and control gate platform (Figs. 3 and 4, Appendix D). Close examination of one of the spalls in the gunite revealed that there was also some slight scaling of the original dam structure in that area.

5) Flashboard pins (Fig. 3, Appendix D) along the length of the spillway are quite rusted. They seem to have not been used for some time. Under normal spillway

FIGURE 3      CRACKING AND SPALLING NEAR EXIT PORTAL OF SLUICE  
TUNNEL

1. The gunite cover and wire mesh should be removed and replaced with a special concrete cover to protect the structural concrete from water erosion or spalling under frost. Until this is done the public should be prohibited from access to the downstream face because of the danger of slabs of gunite dislodging.

2. Deterioration of concrete on spillway piers, the outlet culvert and the gate control platform should be repaired. Reinforcing bars should be tested for degree of corrosion and existing cross section checked with design requirements prior to any concrete patching work.

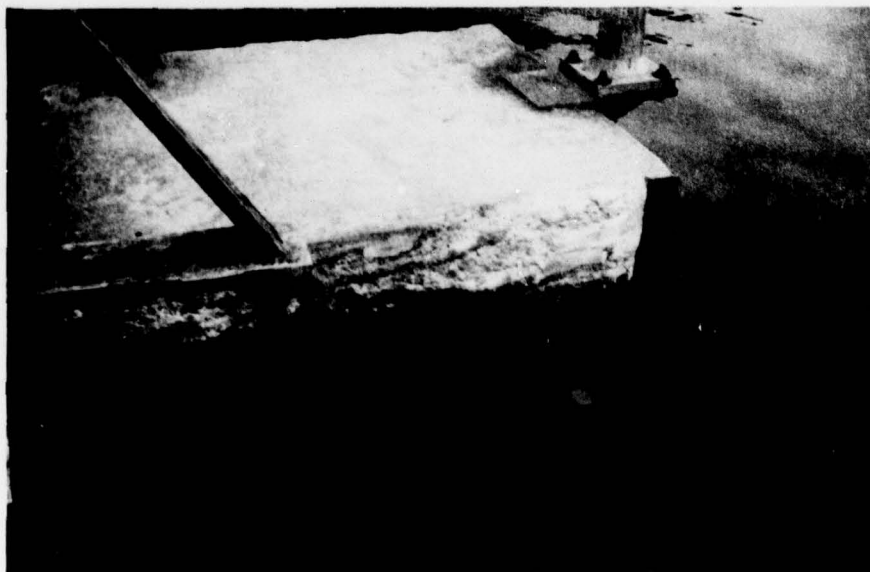
FIGURE 4      SCALING OF CONTROL GATE PLATFORM

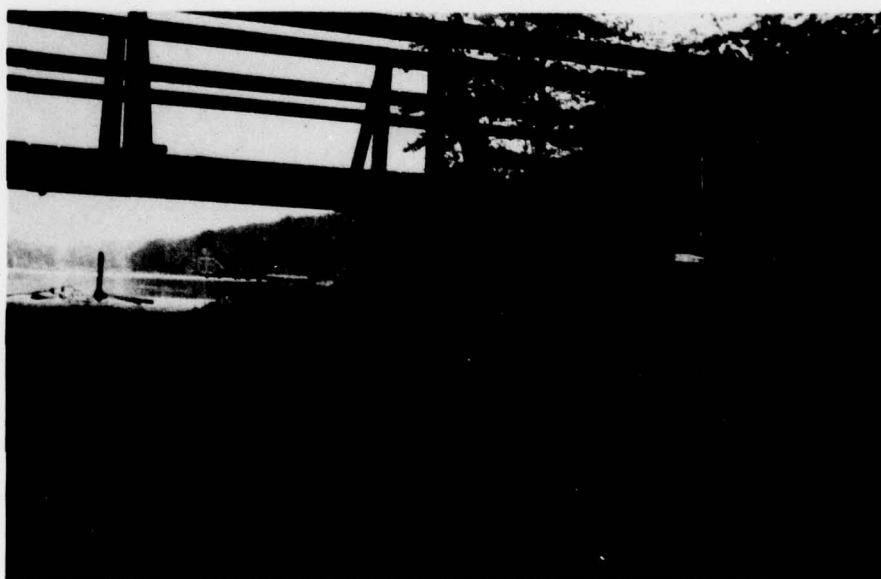
4) A water supply pipeline extends across the dam just below the wooden walkway (Fig. 6, Appendix D). The pipeline appears to be in good condition, with no evidence of leakage observed.

FIGURE 6 LEFT ABUTMENT (DOWNSTREAM)

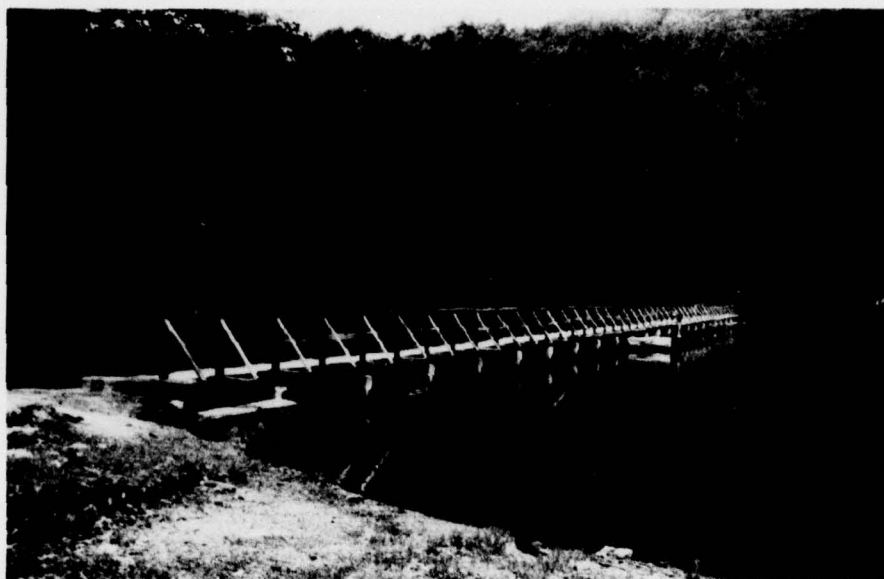
3) The wooden bridge that extends along the top of the dam appears to be in good condition (Fig. 7, Appendix D). Since this bridge provides access to the sluice gate controls, it is essential that it be well maintained.

FIGURE 7 UPSTREAM VIEW OF LAKE KANAWAUKE DAM SHOWING  
WOODEN WALKWAY, GATE CONTROL PLATFORM AND  
LEFT ABUTMENT

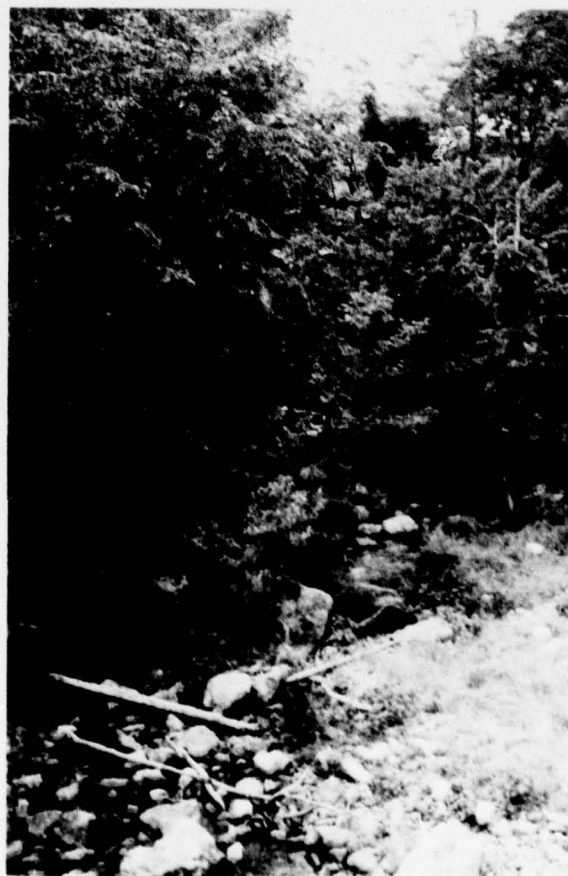
The downstream channel is about 30 to 40 feet wide with side slopes approximately the same as along the reservoir (Fig. 10, Appendix D). Numerous large boulders were observed in the channel out to about 30 feet from the toe of the dam. There is also a considerable amount of debris at the toe (Fig. 11, Appendix D). These serve as an apron and energy dissipator. A few large trees are in the channel and on the slopes farther downstream. The channel slopes appear generally stable, although some minor local slide scars were noted in the vicinity in air photos. About 500 feet downstream there is a large, boulder-covered detention basin (Fig. 12, Appendix D). This basin is used to store water and act as a flood control pond for Sebago Beach (Fig. 13, Appendix D) that lies downstream immediately beyond a two-lane paved road.

FIGURE 10 DOWNSTREAM CHANNEL

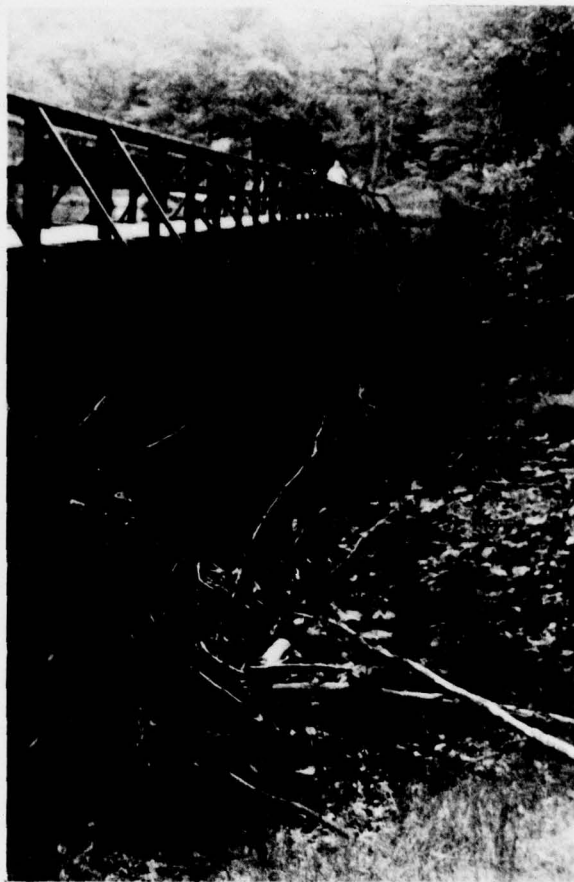
FIGURE 11 DEBRIS AT TOE OF DAM

4) Large pieces of debris immediately downstream and any debris collecting on the spillway should be removed, and the area kept clear of such debris in the future.

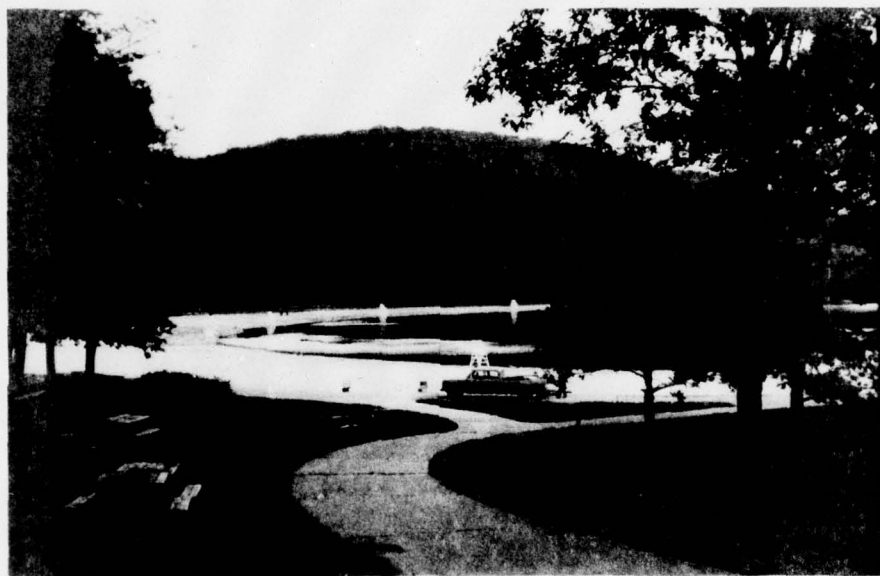
FIGURE 13 SEBAGO BEACH DOWNSTREAM FROM LAKE KANAWAUKE DAM
